Manhole Inspection Summary

Manhole # S33Q1_014MH

Location Address: **800 Seagull Ave** Cross Street: **Cherryland Rd.**

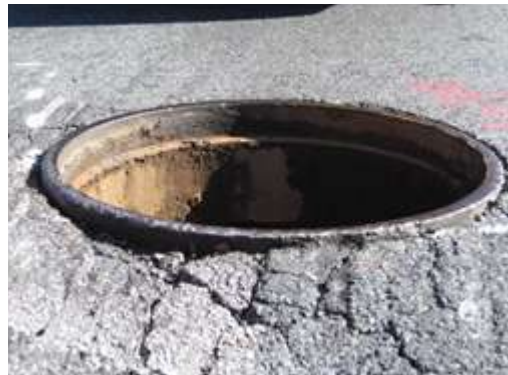
Defect 2

Above grade

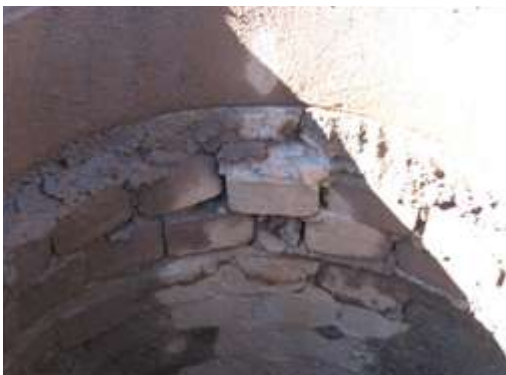
Defect 1

Infiltration: ☐ None ☒ **Joint** ☐ Cracks ☐ Mortar ☐ Roots ☐ Wall

Infiltration: ☐ None ☐ Joint ☐ Cracks ☐ Mortar ☐ Roots ☒ **Wall**

Infiltration

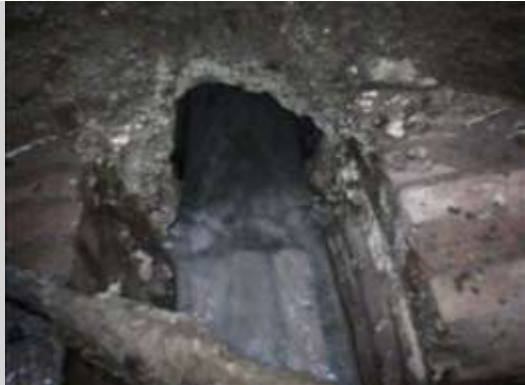
12 O'Clock Outflow

Pipe Height: **15.6** (in.) Rod and Bar (Angled)
Pipe Material: **Clay** ☐ Pipe Lined
Invert Depth: **13.98** (ft.) Flow Characteristics: **Fast**
Deposits: ☒ None ☐ Mud ☐ Sludge ☐ Debris ☐ Grease
Silt Depth: (in.) Deposits Extent:
Infiltration: **None** Pipe Seal Cond: **Unknown**

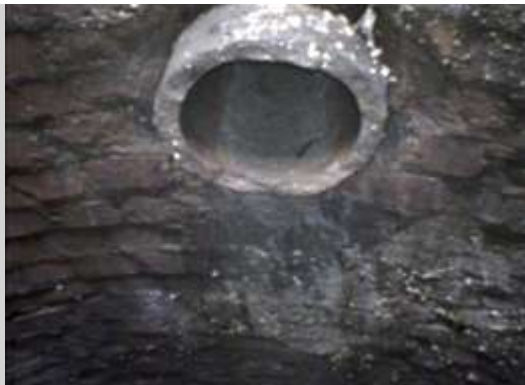
3 O'Clock Inflow

Pipe Height: **8.4** (in.) Rod and Bar (Angled)
Pipe Material: **Clay** ☐ Pipe Lined
Invert Depth: **7.71** (ft.) Flow Characteristics: **None**
Deposits: ☒ None ☐ Mud ☐ Sludge ☐ Debris ☐ Grease
Silt Depth: (in.) Deposits Extent:
Infiltration: **None** Pipe Seal Cond: **Sound**

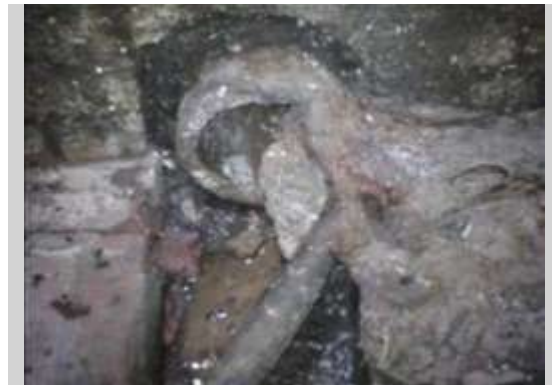
Drop In @ 3 O'Clock

Drop: **Outside** Rod and Bar
Angled: **Yes** Reading: **11.78** (ft.)
Inv Depth: **12.78** (ft.)
Drop Condition: **Open**

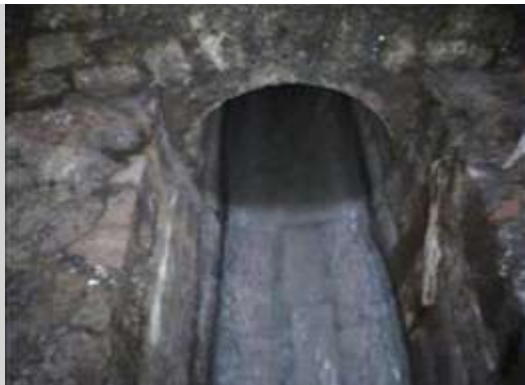
6 O'Clock Inflow

Pipe Height: **13.2** (in.) Rod and Bar (Angled)
Pipe Material: **Clay** ☐ Pipe Lined
Invert Depth: **13.69** (ft.) Flow Characteristics: **Fast**
Deposits: ☒ None ☐ Mud ☐ Sludge ☐ Debris ☐ Grease
Silt Depth: (in.) Deposits Extent:
Infiltration: **None** Pipe Seal Cond: **Sound**
